Musterfläche zur Fassadensanierung

Fassadenrestaurierung der
Physikalisch-Technischen Bundesanstalt, Observatorium
2008

Restoration of The Façade of
The Federal Agency For Physics And Technology
Observatory (National Metrology Institute)
2008

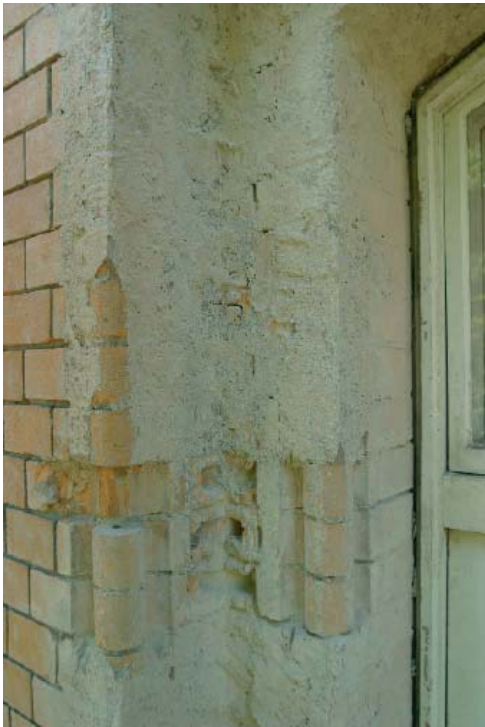
Nach der Abnahme der Überputzung wurde deutlich, dass der bauzeitliche Ziegelverband mit den Formsteingewänden der Fensteröffnungen weitgehend erhalten ist.

Beschädigte und überputzte Formsteingewände

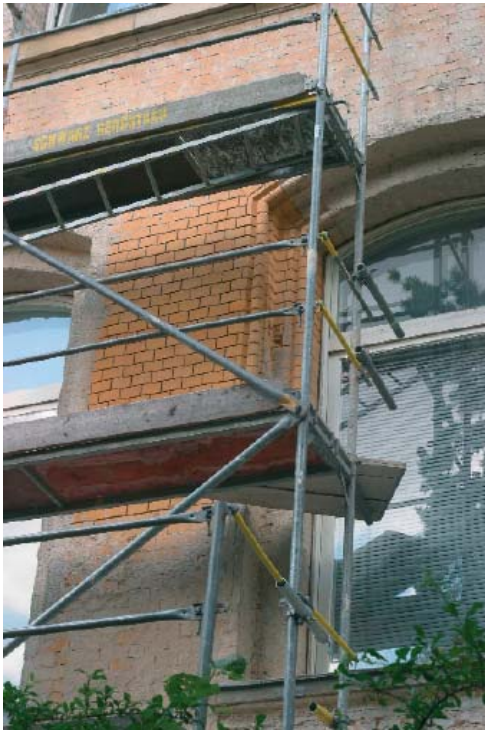
sample area of the restored façade

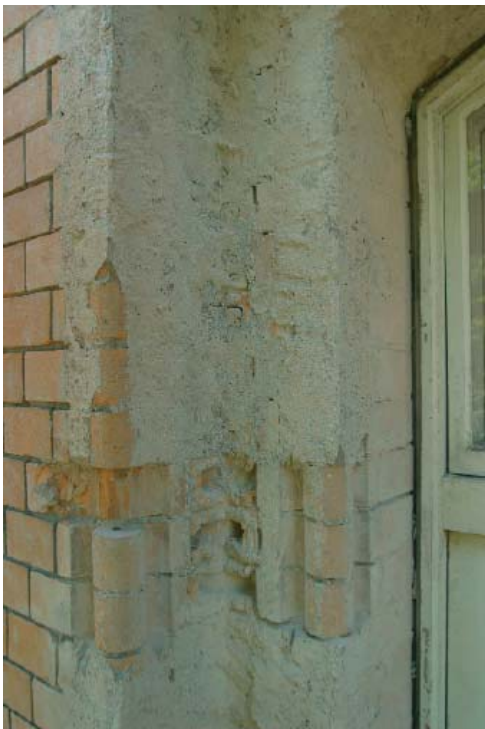
actual condition of the façade
